On the Line Q Degradation in Hydrogen Masers

L. G. Bernier, G. Busca, H. Schweda Observatoire de Neuchâtel, Switzerland

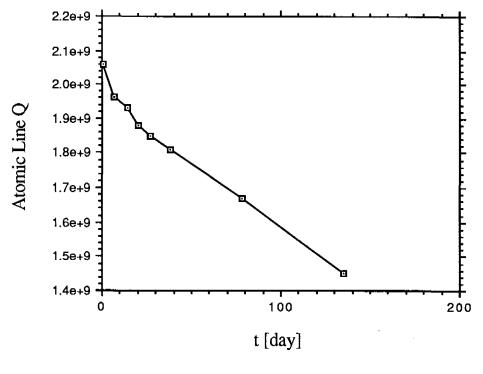
Figure 1
Atomic Line Quality Factor vs Time

The effect of a bad Teflon coating on the maser behavior was observed for several months. Figure 1 shows the evolution of the line Q starting just after the re-coating of the storage bulb. The origin of the time axis is the first day of oscillation. It can be observed that there is a decelerating degradation, during the first days, and then the degradation rate stabilizes. Figure 2 shows a linear regression of the linear part of the line Q degradation. The equation of the linear regression is as follows: $Q = 1.9528 \times 10^9 - 3.7052 \times 10^6 \text{ t}$ [day]. The relative degradation rate is 0.19 %/day. Figure 3 shows the amplitude of the maser signal versus time. By amplitude we mean the detected peak amplitude at the 5.7 kHz last IF in the receiver. Again there is a decelerating decay, at first, and then the rate of decay stabilizes. The amplitude steps are due to hydrogen pressure resettings. Figure 4 shows the linear part of the curve with the amplitude steps corrected by translation of the constant hydrogen pressure segments. A linear regression of the data points yields: A $[V] = 11.741 - 4.0735 \times 10^{-2} \text{ t}$ [day]. The relative for the curve with the data points yields: A $[V] = 11.741 - 4.0735 \times 10^{-2} \text{ t}$ [day]. The relative forms are the constant hydrogen pressure segments.
